**Aurora Corridor Traffic Safety Project**  
**Notes From Bus Tour**  
**December 3, 2008**

**10 AM to 10:45 AM Southbound from North 130<sup>th</sup> Street**

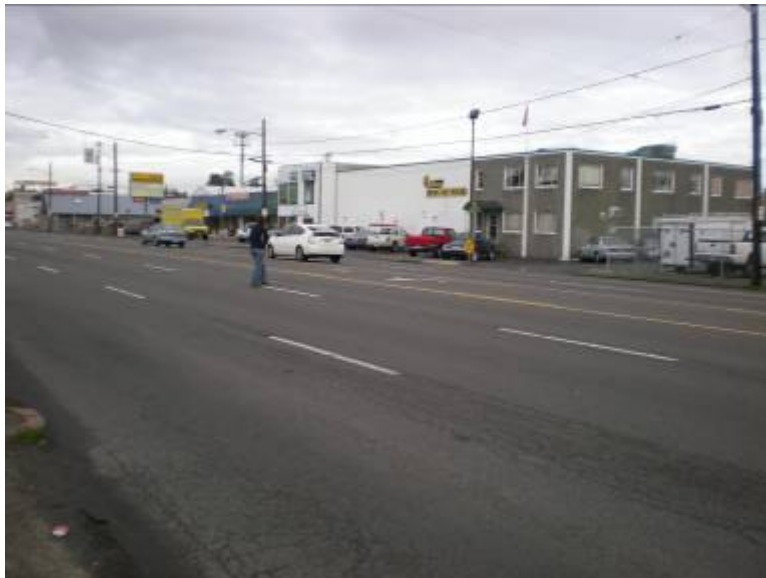
- Mid point of a 10 block stretch without a signal or marked crosswalks
- Transit stops on east and west side of Aurora
- Business encroach within the right-of-way
- Street lighting needs improvement

*Crossing Aurora at North 95<sup>th</sup> Street*

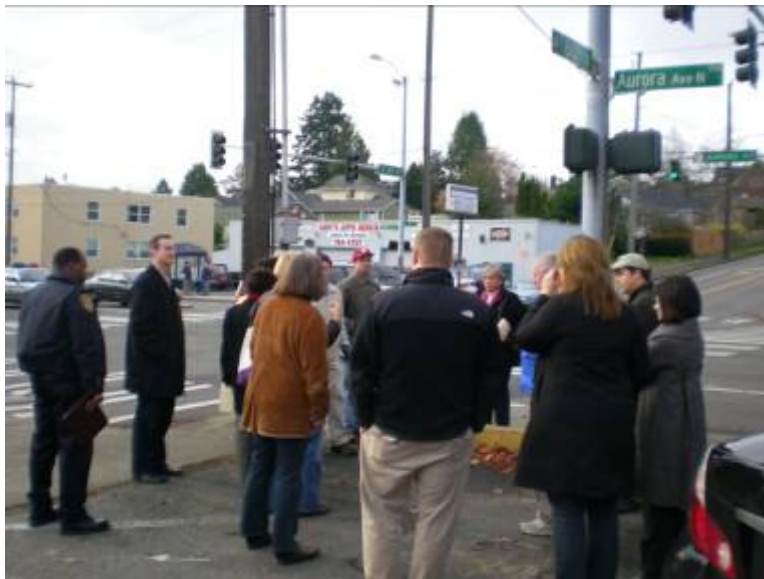
- Long conversation here about risky driver behavior and impacts to students walking to Bagley Elementary
- Bagley Elementary parents and students walk to school via a walking school bus through this intersection

- Add Pedestrian Countdown Signals
- Drivers often making risky left and right turns onto Aurora due to congestion during peak hour traffic
  - Red light camera could reduce turns after the signal has turned red

*The Task Force at North 80<sup>th</sup> Street and Aurora*

- Key location for education/public awareness event or activity
  - Coordinate with enforcement effort if possible
- Review placement of school zone signs and/or create “virtual school zone” to improve driver awareness

- Entire intersection needs evaluation
  - Improve lighting so students walking to school can be better seen by drivers
  - Adjust pedestrian signal for a “leading walk” phase

- Assess the possibility for left turn signals and left turn pockets for drivers attempting to turn northbound or southbound from N 80<sup>th</sup> St

- Could peak hour turning restrictions improve safety?
- Metro is exploring the possibility of eliminating the bus stop here when Rapid Ride is implemented

- Key intersection for enforcement activities

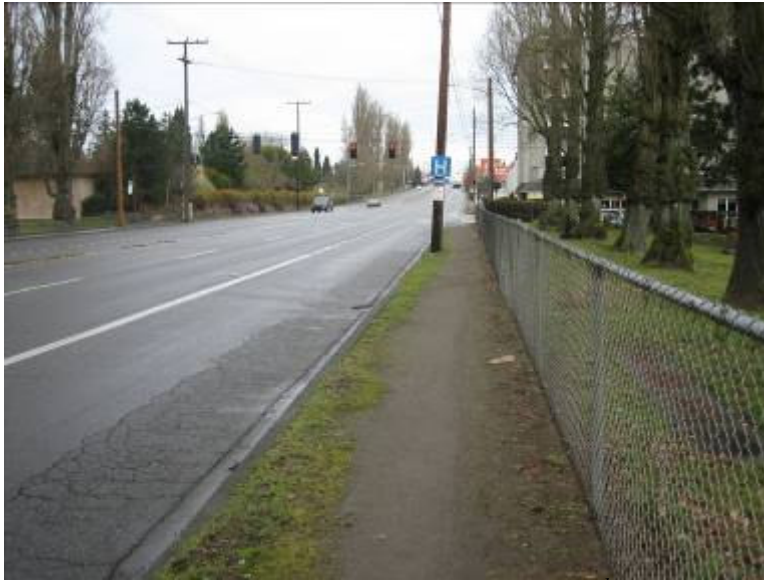
- Northwest Hospital is accessed via N 115<sup>th</sup> St
- Pedestrian fatality has occurred at this intersection
- No sidewalks on east or west side of the street south of N 115<sup>th</sup> St
- No crosswalk on the south leg on the intersection
- Add Pedestrian Countdown Signals

*Looking north towards the intersection of North 115<sup>th</sup> Street and Aurora*

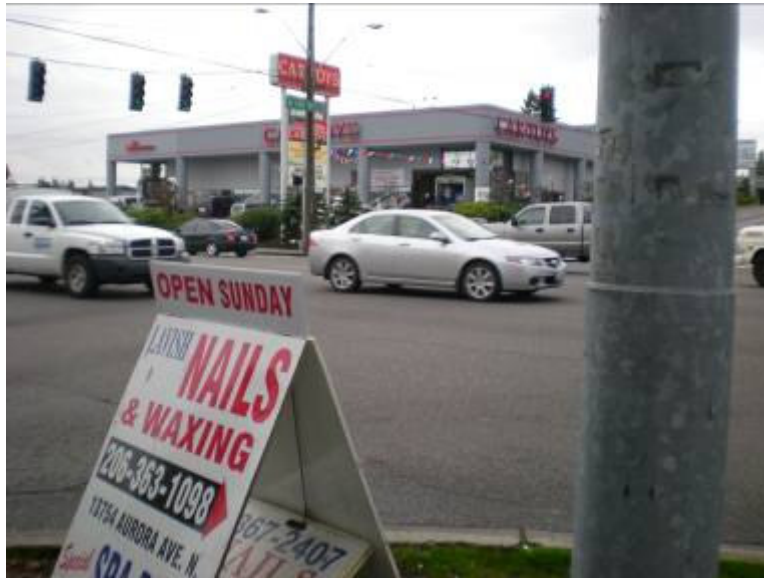
- Add Pedestrian Countdown Signals
- Overpass at N 130<sup>th</sup> St is not ADA accessible
  - Existing crosswalk configuration needs to be changed
  - Add a marked crosswalk on the north leg of the intersection with new ADA ramps on all four corners
  - Major senior housing developments one block west at Linden and N 130<sup>th</sup> St

- Seniors must cross Aurora to access Albertsons for groceries
  - A major increase in senior housing units is expected in this area in the coming years
- Sign clutter continues in this area
  - Enforcement of sandwich board/a-frame sign policies would help improve pedestrian environment
- Ingraham High School students travel to and from school via Aurora bus routes
  - Create “virtual school zone” to improve driver awareness
- Rear-end and angle collisions are common at this intersection

*The intersection of North 130<sup>th</sup> Street and Aurora*
